# THE DECI REPORT - JANUARY 2002

## ACOUSTIC EMISSION TESTING OF STRUCTURES EXHIBITING HIGH LEVEL VIBRATION AND AIRBORNE NOISE

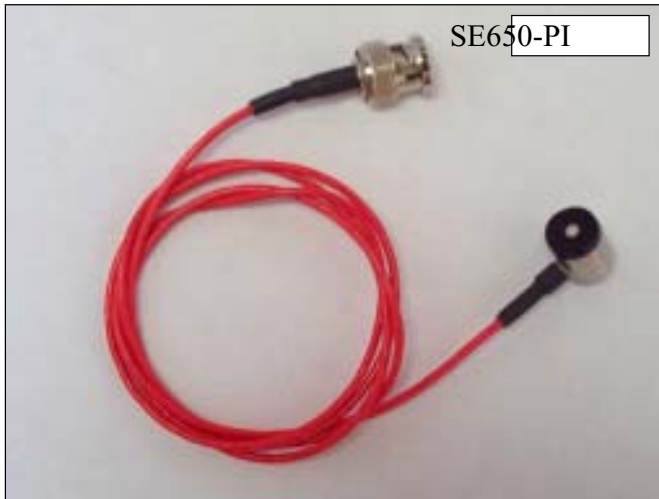
the following reason. Out-of-plane (OP) high frequency airborne noise incident on a plate produces a low frequency flexure wave component that can be filtered out with modal ratio filtering. This same airborne signal hits the transducer with poor acoustic isolation between the active element and the case, producing a high HF/LF ratio and therefore can be interpreted as a signal due to crack growth. The solution to this problem was to replace the SE9125-MI transducer with the SE650-PI transducer shown in the photograph. This sensor has

a small aperture (0.125 in. dia.) , higher frequency response, is not mass loaded, and has 20dB of acoustic isolation between the active element and case of the transducer. The diameter of the transducer is 0.500 in. and is provided with an integral low noise cable and integral 20dB preamplifier. We believe it to be the smallest integral preamplifier AE transducer in the world.
