## Using Acoustic Emission to Monitor Fatigue Cracks on the Bridge at FAST

by Shakoor Uppal, Dio Yoshino and \*Hal L. Dunegan

### Summary

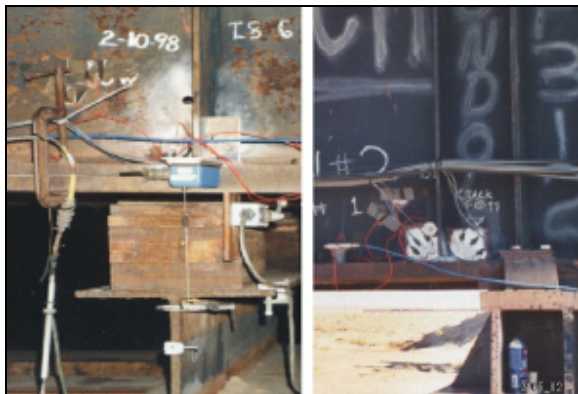
**Exhibit 2. Instrumentation at Crack Locations**

Data transducers and strain gages were installed at the weld crack and flange crack locations. In addition, a string potentiometer was installed under the flange crack location. This string potentiometer provided the number of cycles of displacement data that was correlated with the AE data from the flange crack. It also provided an indication of train presence over the bridge for the start and pause of data collection.

Each crack location had a "trigger" sensor located near the crack tip, and a "data" sensor located 10 inches from the trigger sensor. Each sensor collects both high and low frequency signals by using piezo-electric crystals. The purpose of using a trigger sensor in conjunction with a data sensor is to isolate a small area around the crack tip from which to collect AE signals. Transducers, strain gages, and a string potentiometer were connected to AE equipment as necessary to provide the parametric

inputs for recording data during different test runs. The system was on continuously, but the instrumentation was set up such that data was recorded only when the train was present on the bridge. Exhibit 2 shows the instrumentation at both crack locations, and Exhibit 3 shows the AE equipment in use.
